Manhole Inspection Summary

Manhole # S55E__024MH

Insp Date: **7/22/08 2:19 PM**

Location Address: **103 s conkling st**

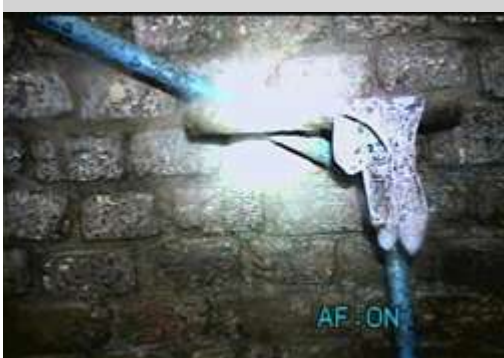
Defect 4

☒ **Evidence Of Surcharge** Depth: **8.5** (ft.) ☐ Active Surcharge Present

evd surcharge

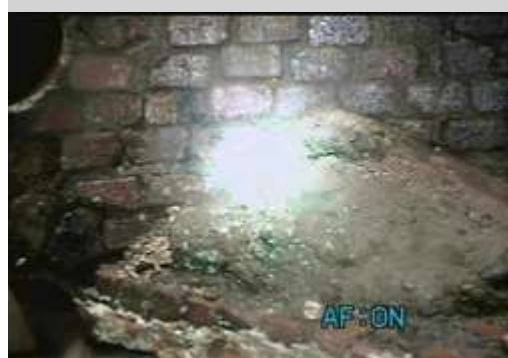
Defect 3

Condition: ☐ Sound ☐ Cracked ☐ Root Intrusion ☐ Deteriorated ☐ Leaks ☒ **Debris**

bench debris

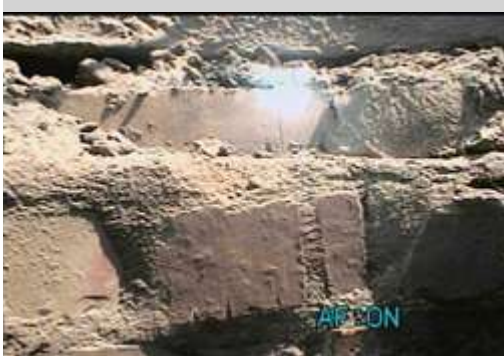
Defect 2

Condition: ☐ Sound ☐ Cracked ☐ Root Intrusion ☐ Loose Brick ☒ **Deteriorated**

deteriorated

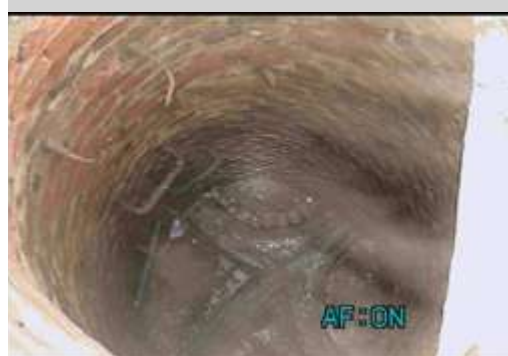
Defect 1

Count: **5** Missing: **2** ☒ **Corroded**

steps

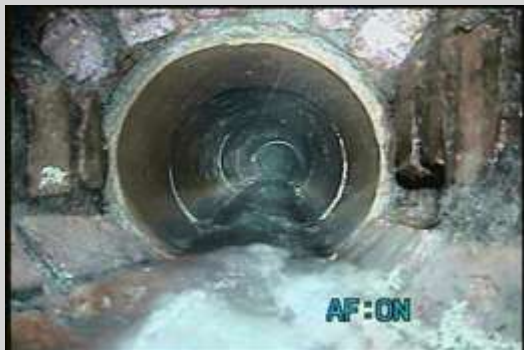
12 O'Clock Outflow

8 in. Circular Gravity Sewer
Pipe Out @ 12 O'Clock

Pipe Material: **Clay** ☐ Pipe Lined

Invert Depth: 11.00 (ft.) Flow Characteristics: **Fast**

Infiltration: **None** Pipe Seal Cond: **Unknown**

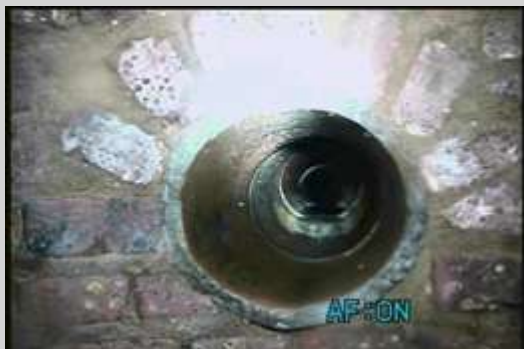
3 O'Clock Inflow

8 in. Circular Gravity Sewer
Pipe In @ 3 O'Clock

Pipe Material: **Clay** ☐ Pipe Lined

Invert Depth: 7.66 (ft.) Flow Characteristics: **Fast**

Infiltration: **None** Pipe Seal Cond: **Unknown**

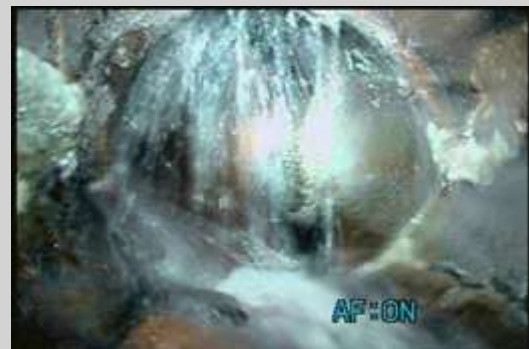
Drop In @ 3 O'Clock

Drop: **Inside** **Direct**
Angled: Reading: 0.00 (ft.)
Inv Depth: 10.90 (ft.)

Drop Condition: **Open**

Connects To: **House connection / Service line**

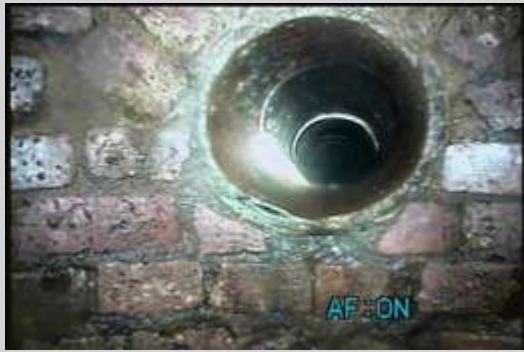
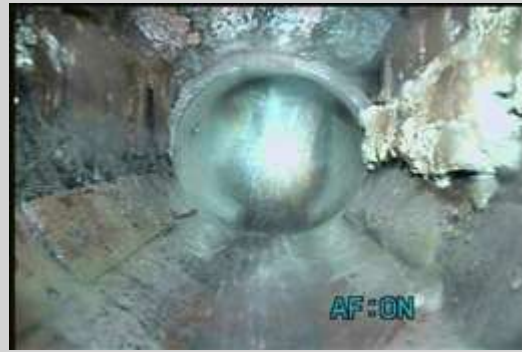
6 O'Clock Inflow

Pipe In @ 6 O'Clock

Drop In @ 6 O'Clock

Invert Depth: **8.41** (ft.) Flow Characteristics: **Fast**

Drop: **Inside** **Direct**

Inv Depth: **10.60** (ft.)

Drop Condition: **Open**

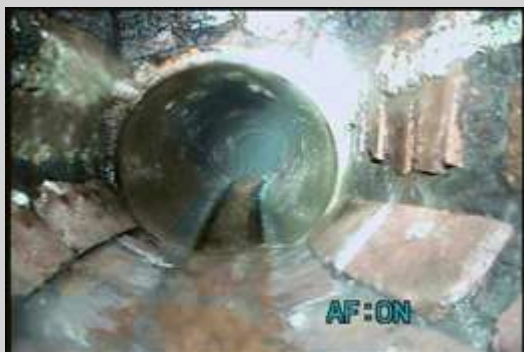
9 O'Clock Inflow

Pipe In @ 9 O'Clock

Pipe Material: **Clay** ☐ Pipe Lined

Invert Depth: **10.80** (ft.) Flow Characteristics: **Fast**

Infiltration: **None** Pipe Seal Cond: **Unknown**
